Acro Dental Clinic
Director
Oh, Sang-Yoon

Implant position: #24

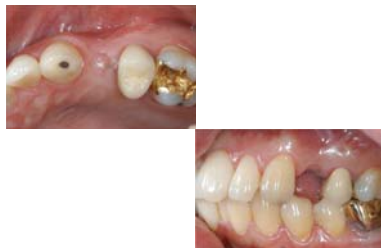
Fig. 1. A Preoperative intraoral view (postext. 4ms). Horizontal deficiency at labial side (#24).

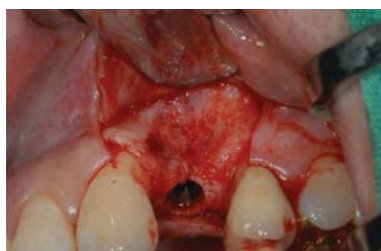
Fig. 5-6. Implantation (TS III SA) & sinus lifting. Labial bone deficiency.

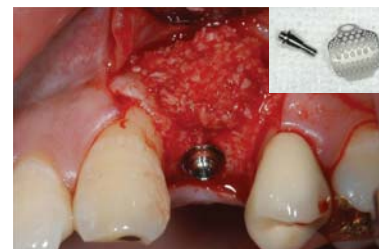
Fig. 7. Bone Graft for labial augmentation.

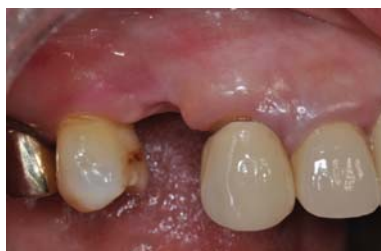
Fig. 1-2. 59 years old female visited to place an implant at upper right 1st premolar missing site. She received implant 7 years ago and it was retrieved 7 months ago due to the mobility of the implant which involved in severe peri-implantitis. Soft tissue was well healed but it showed insufficient tissue volume.

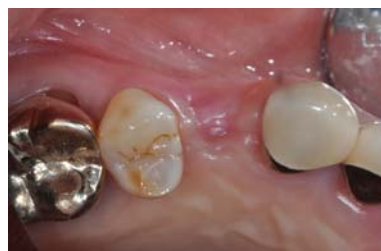
Fig. 3. Panoramic view shows relatively radiolucent image of premolar missing site.

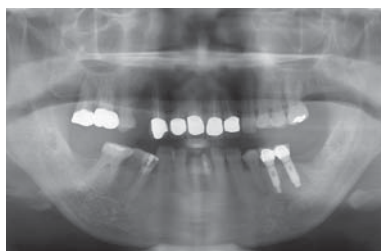
Fig. 4. Bone was exposed after mucoperiosteal flap elevation. Bone healing was very poor even 7 months after the fixture removal.

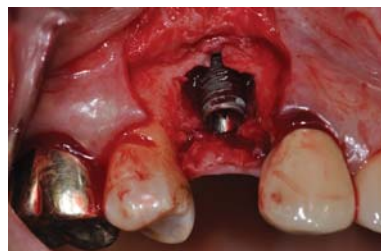
Fig. 6. Bone defect around the fixture was carefully examined to select a SMARTmembrane. Buccal and proximal and slight palatal bone defects were observed.

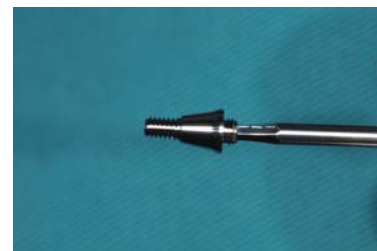
Fig. 7-8. Height of 1.0mm was selected and connected on the fixture.

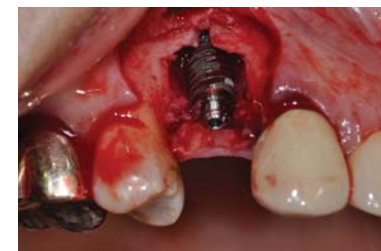
Fig. 10. An allogenic bone substitute (SureOss 0.25cc) was grafted to fill the bone defects.

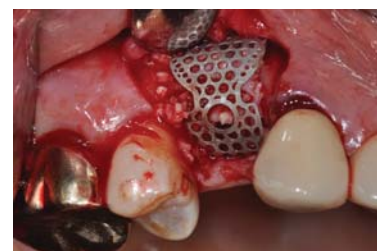
Fig. 11-12. The SMARTmembrane was fixed on the height using a healing abutment. The SMARTmembrane was directly applied without modification.

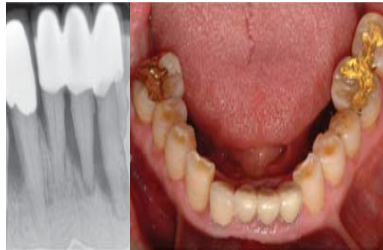
Fig. 1. A 75 year old male with failing fixed bridge at sites #32 to #42 due to advanced periodontal pathology.

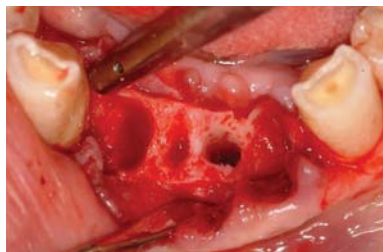
Fig. 3. Final osteotomy in sites #31 and #42.

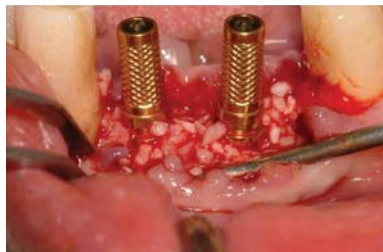
Fig. 5. Temporary abutments attached to the implants and mixture of particulated autogenous bone and FDA(OsteOs) placed into defective socket. Barrier membrane was not used.

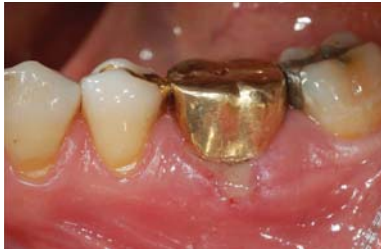
Fig. 1~2. Pre-operative photo and radiograph of extraction (Root bifurcation lesion owing to improper post surgery).

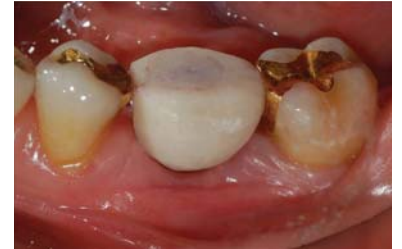
Fig. 9~10. Final prosthesis setting at 3 months after implant placement.

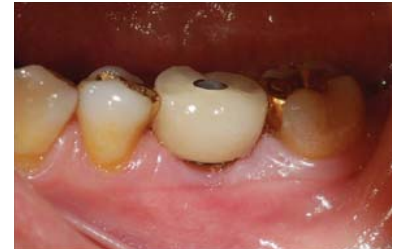
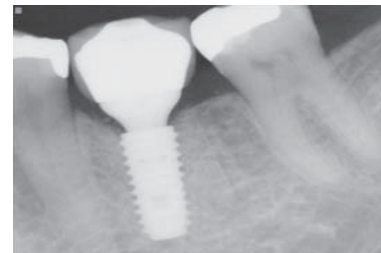
Fig. 11~12. 9 months after implant placement. Well-matured soft tissues are shown.

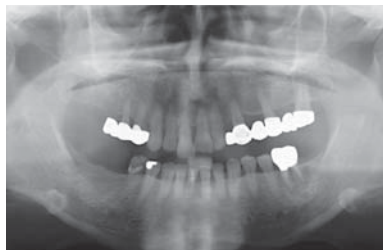
Fig. 1~2. #16, 17, 46, 47 TSIII SA Implant placement. One-stage method (2010. 5. 31).

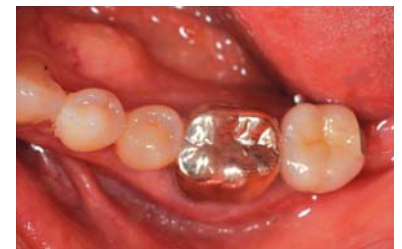
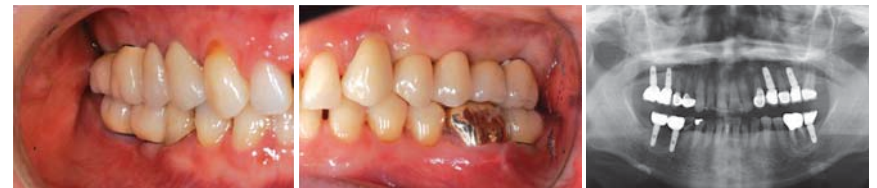
Fig. 16~18. Final prosthesis (2010. 12. 22).

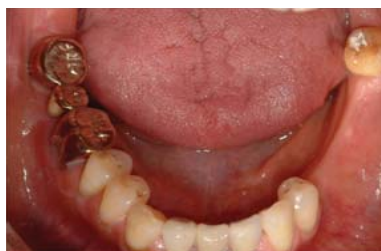
Fig. 2. Minimal attached gingiva was observed and considerable horizontal alveolar bone resorption was estimated in lower left quadrant.

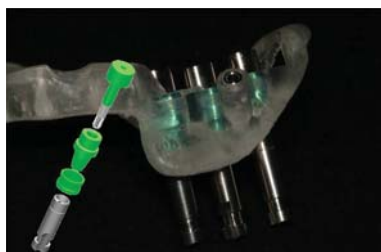
Fig. 4. Implant replica placed into the sleeves of surgical guide for making working cast.

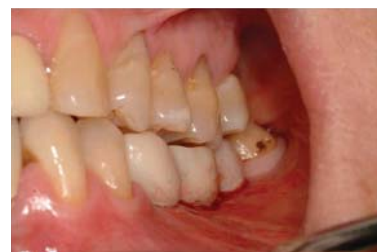
Fig. 11. Minimally invasive surgery and immediate loading by prefabricated provisional prosthesis.

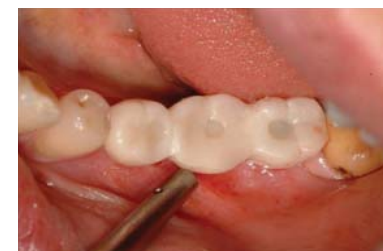
Fig. 10. Immediately loaded screw-retained provisional prosthesis.

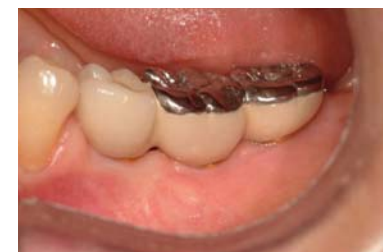
Fig. 12. Definite prosthesis delivered after 5 months of loading by provisional restoration.

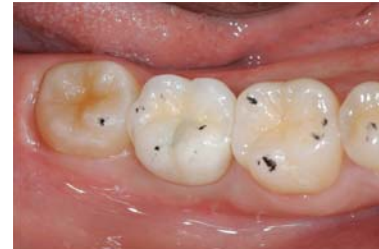
Fig. 9. Final prosthesis.
Harmonious gingival line & profile.

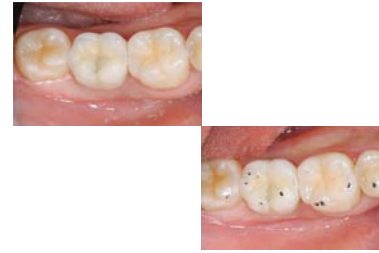
Fig. 11. 6 months later.
Maintain occlusal stability by no sinkdown.

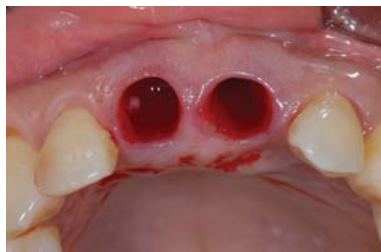
Fig. 3-4. After extraction of the teeth throughout curettage was performed. Loss of the labial bone plate was observed.

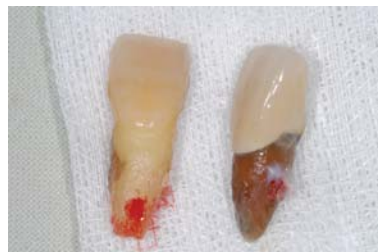
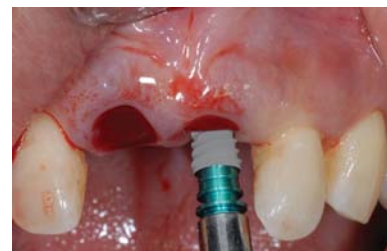
Fig. 5-6. After drilling at palatal side of the extraction sockets TSIV SA \varnothing 4.5x11.5mm were installed. Initial torque was over 40Ncm and ISQ value was 73/74 each.

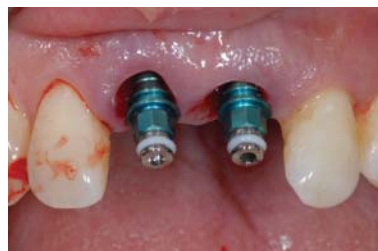
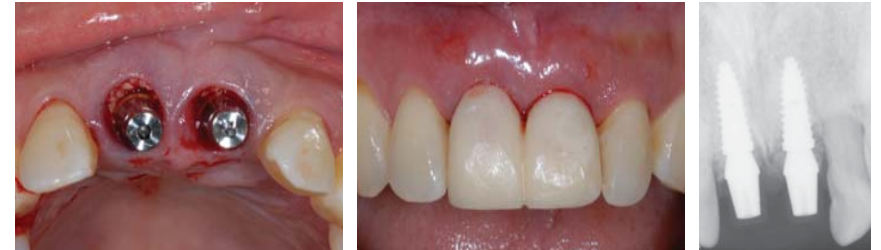
Fig. 7-9. Non functional immediate restoration was tried. Rigid abutments are connected on the fixtures with 30Ncm and allogenic bone graft material (SureOss 0.2cc+0.2cc) was grafts on labial bone defect. Temporary bridge was fabricated and delivered with out of occlusion. POP Standard X-ray shows well positioned TSIV SA fixtures.

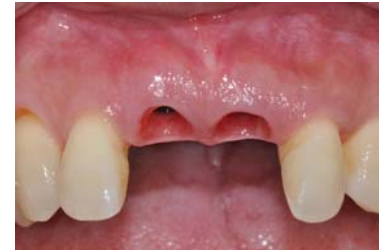
Fig. 10-11. 5 months after temporization patient visited with good gingival health condition. After impression taking cementation type crowns are fabricated over customized abutments.

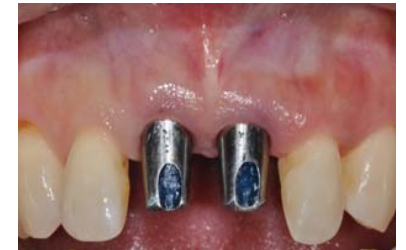
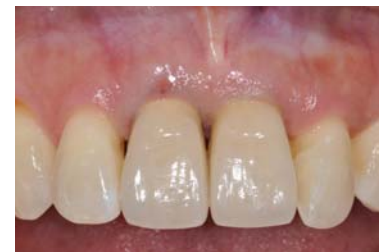
Fig. 12-13. Both crowns are delivered using a temporary cement. They showed harmonized crown and soft tissue.

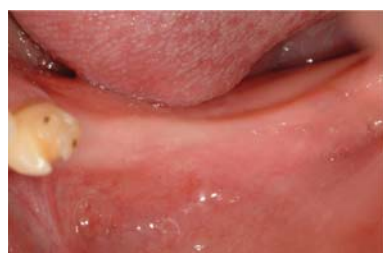
Fig. 3. View of surgical site. Minimal attached gingiva was observed in the molar region.

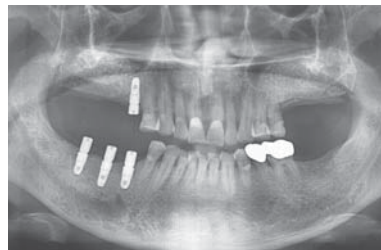
Fig. 2. SSII SA fixtures were placed in #15, #45, #46, #47 missing area. Maxillary Sinus Graft procedure in Rt. & Lt. sides was done with lateral window technique.

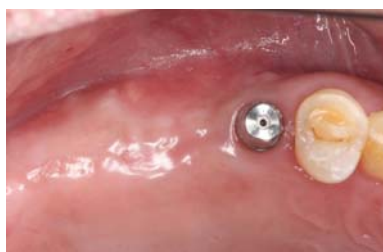
Fig. 3-4. At four months after sinus graft procedure, SSII SA fixtures were planned to be placed in #16 and #17 missing area.

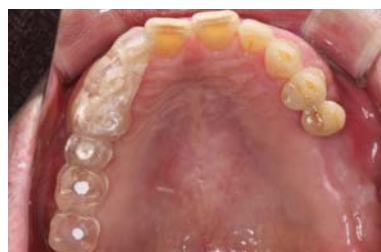
Fig. 5. Sufficient bone volume was acquired in both sides of sinus cavity.

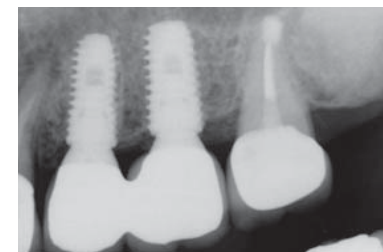
Fig. 10. Periapical radiograph 6 months after immediate loading. Final prosthesis was delivered.

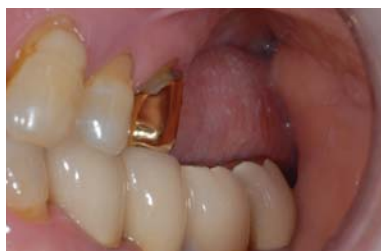
Fig. 1. 64 years old female visited my clinic to receive implants. She extracted #27 3 months ago for the mobility of the tooth after bridge cutting. Excessive occlusal clearance due to vertical bone loss was observed.

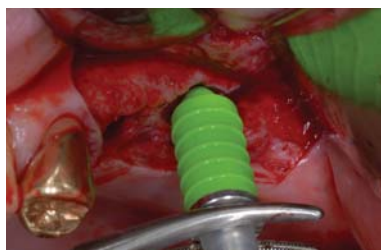
Fig. 5. The remaining bone height of #26 was sufficient and #27 was not. Sinus lift procedure was performed at #27 site using the CAS kit. Hydraulic membrane lifting procedure was done after penetration of the sinus floor.

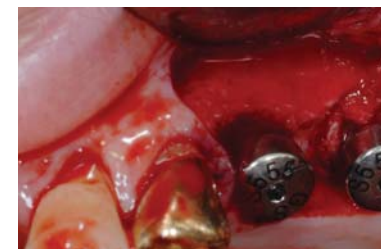
Fig. 8. After minor autogenic bone graft around #27i bone defect 1-stage surgery was done by connecting healing abutments.

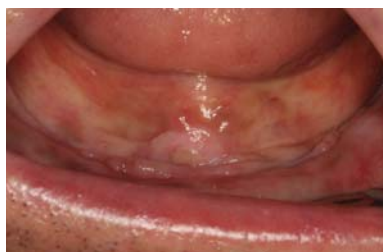
Fig. 1. Preoperative intraoral view of 72-year old male patient. Ulcerative lesion is observed in the mouth floor.

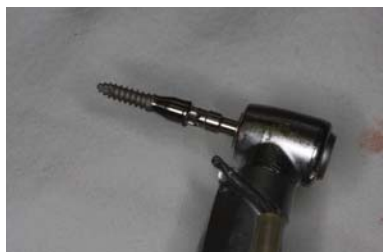
Fig. 3. MS port implant fixture (2.5mm in diameter, 8.5mm in length).
